# IMPORTANCE OF INSPECTION OF THE OIL-OIL SHELL AND TUBE HEAT EXCHANGER FOR NEEDS OF SUSTAINABLE DEVELOPMENT AND ENVIRONMENTAL PROTECTION

**Key words:** Oil-oil heat exchanger, inspection, ndt methods, corrosion rate, remaining life

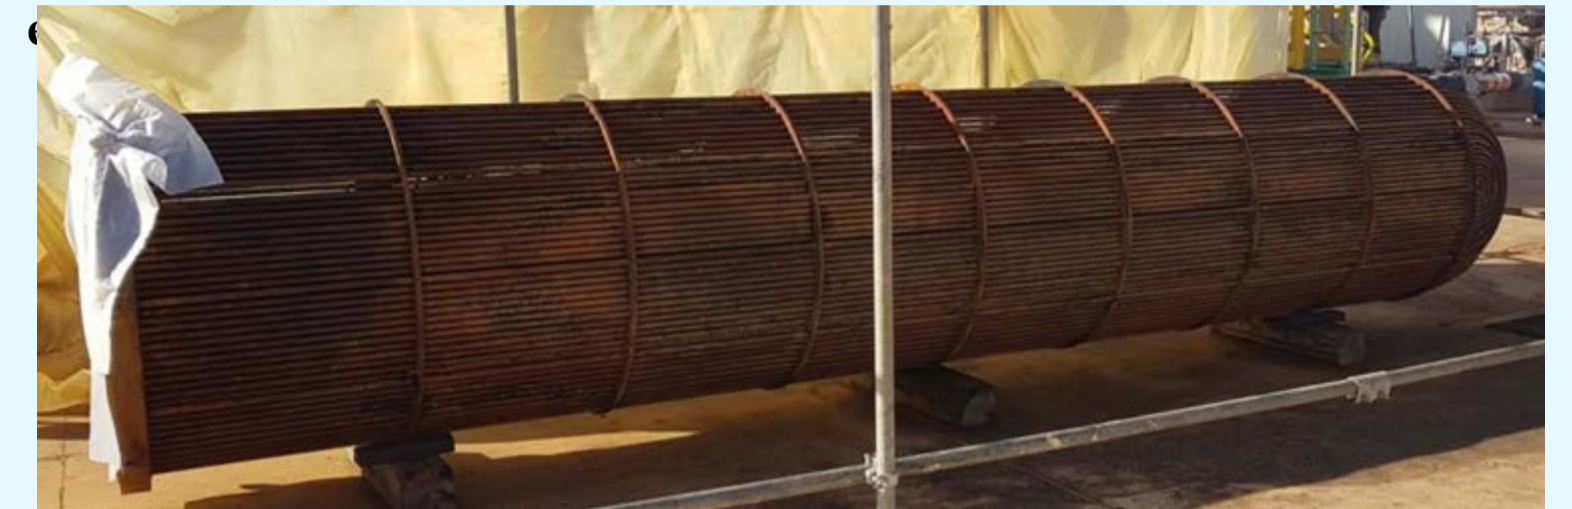
Figure 2. The tube bundle after cleaning - in good condition without visible damages and deformations

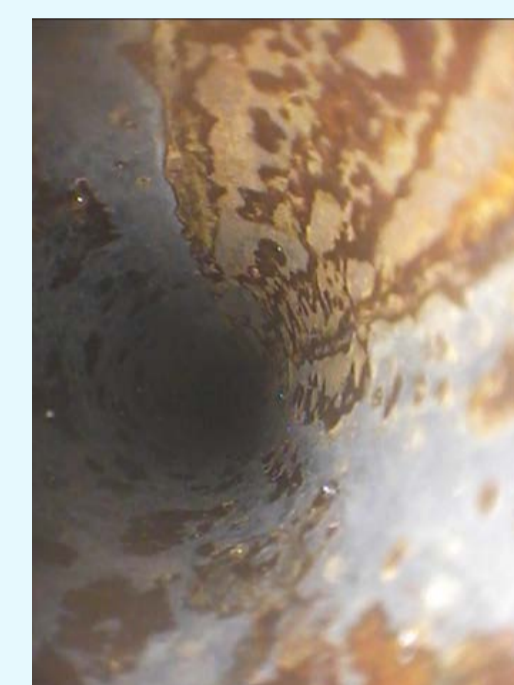
Figure 3. Surface corrosion was observed on the internal side of the tubes (all tubes were in the similar condition in time of inspection)

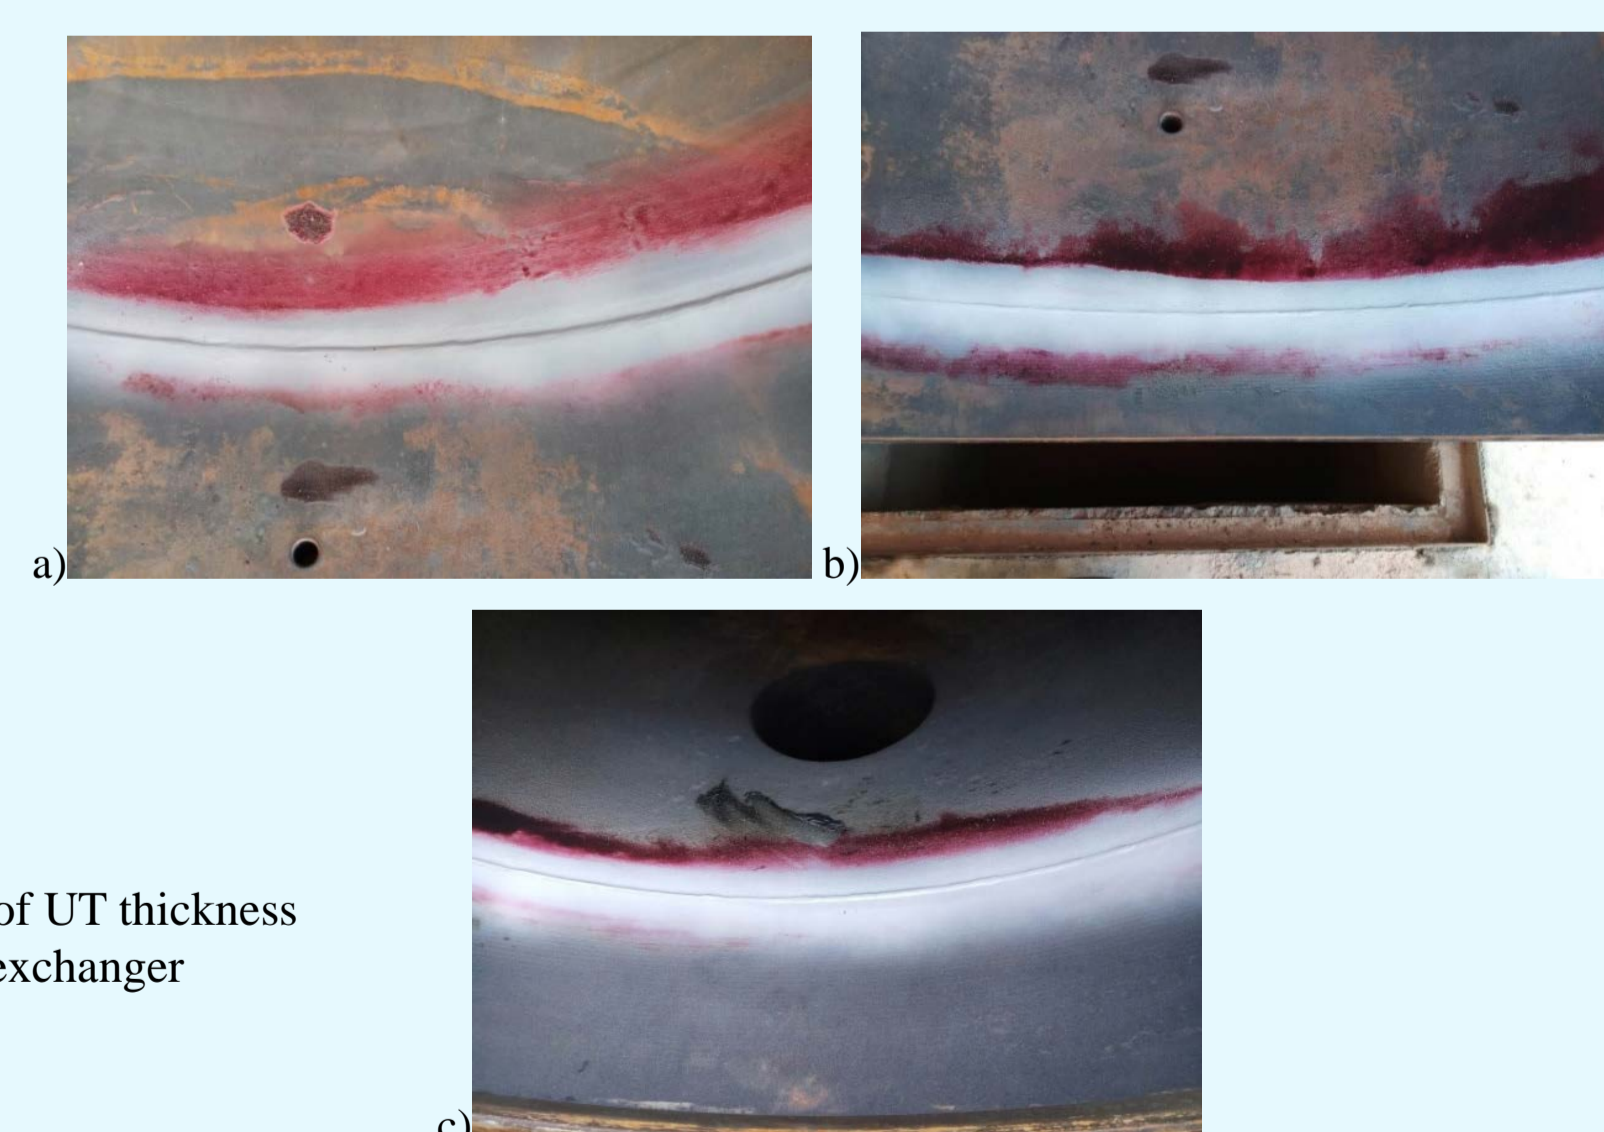
Figure 5. Results of PT tested of the weld joints a) 1 b)2 and c)6.

The inspection included visual testing, liquid penetrant testing and ultrasound thickness measurements. The inspection revealed no corrosion or any damage and all of the essential sections/components of the oil-oil heat exchanger is safe to operate until next scheduled inspection.
